# VICROADS FOAM BITUMEN INVESTIGATION WORKSHOP

# **PRELIMINARY DESKTOP**

# **STUDY – THINGS WHICH**

# **SHOULD BE INCLUDED**

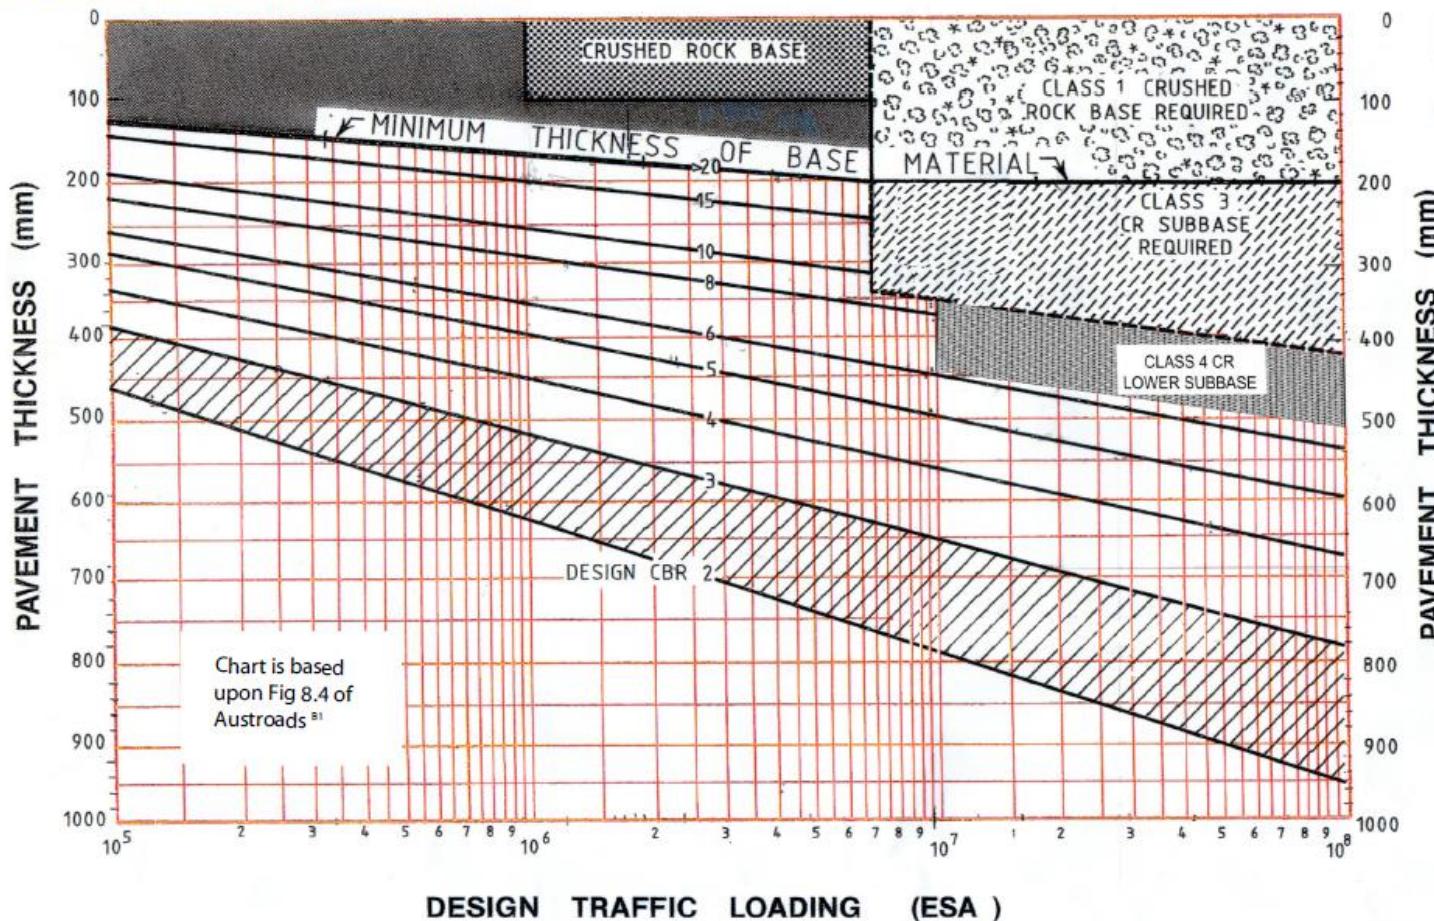
Appendix F

Design Chart For Unbound Flexible Pavements

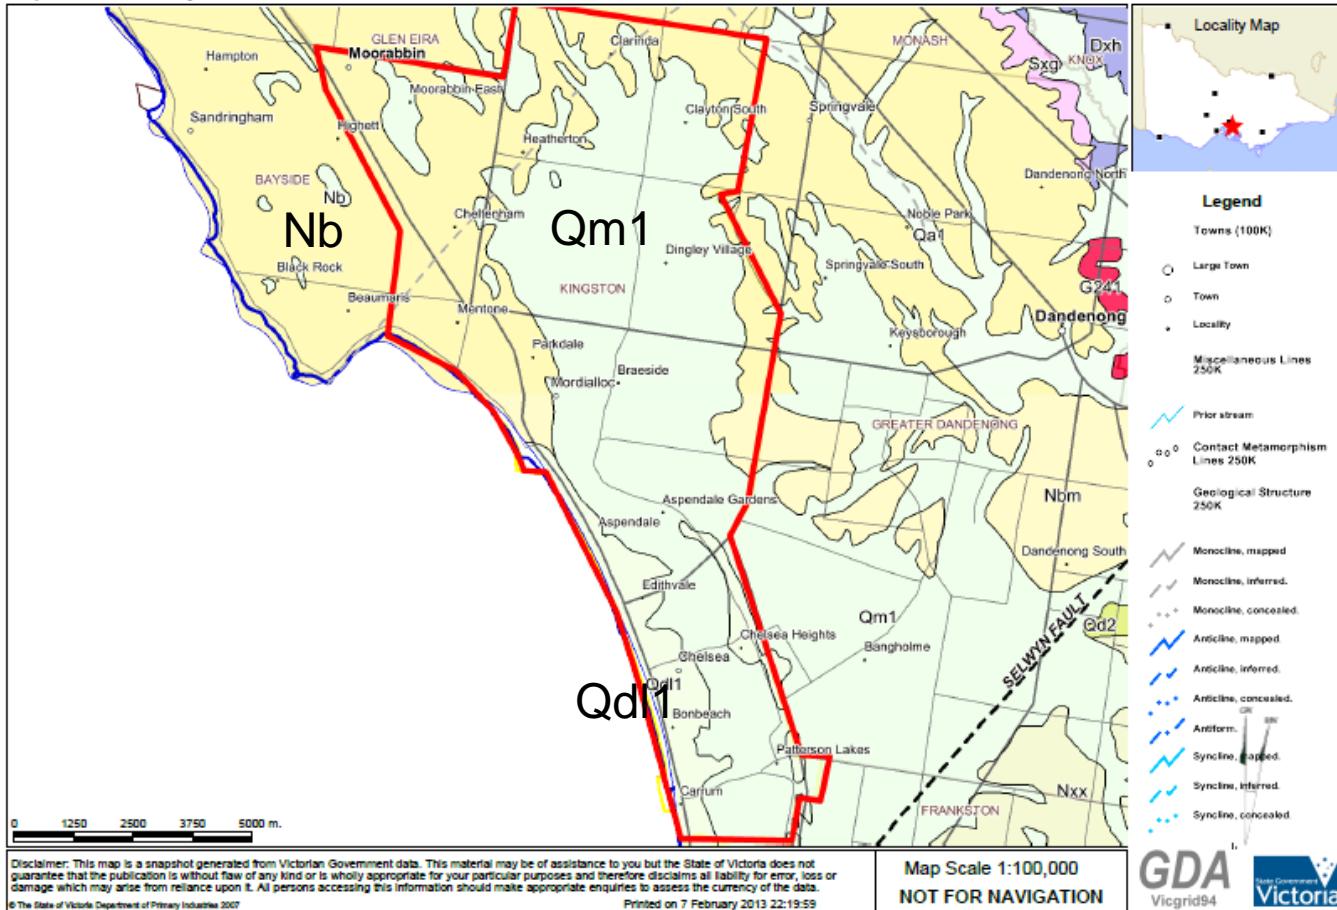
PLAN SOURCE: Department of Primary Industries

Nb -  
Brighton  
Group  
(Fluvial:  
gravel,  
sand, silt)

Qd1 -  
Unnamed  
coastal  
dune  
deposits

Qm1 -  
Unnamed  
swamp and  
lake  
deposits

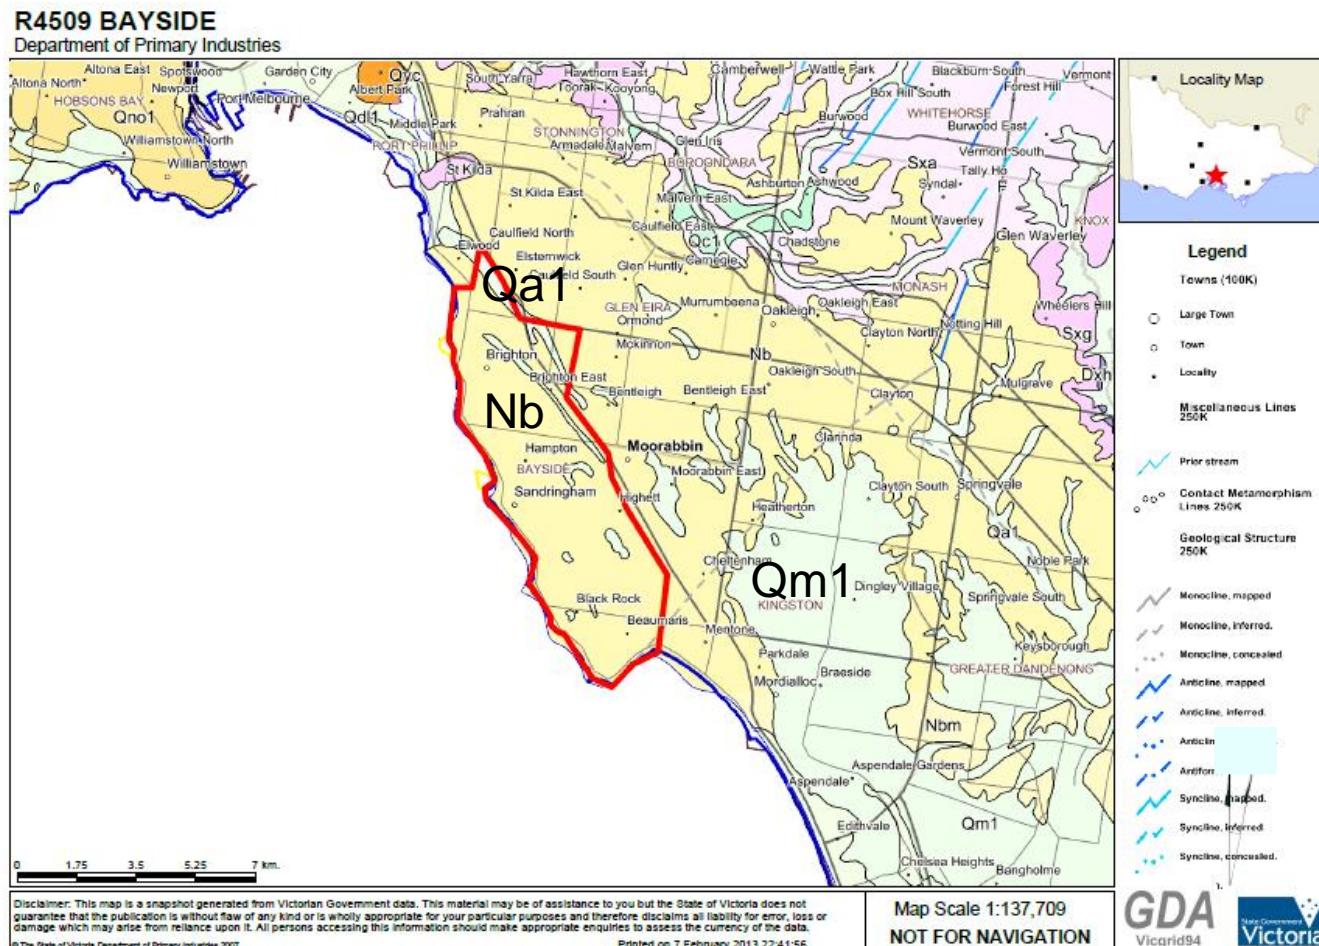
PLAN SOURCE: Department of Primary Industries

Nb -  
Brighton  
Group  
(Fluvial:  
gravel,  
sand, silt)

Qa1-  
Unnamed  
alluvium

Qm1 -  
Unnamed  
swamp and  
lake  
deposits

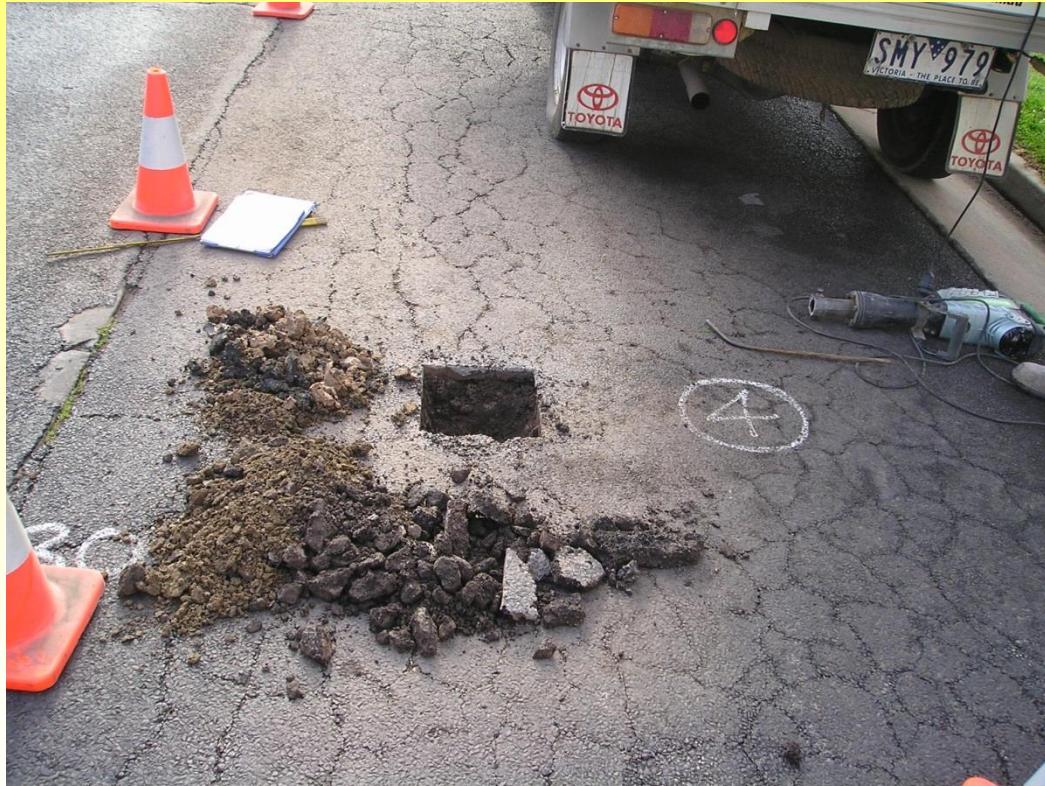
## Crocodile Cracking

Crocodile cracking is likely associated with a fatigued pavement, inadequate pavement thickness or material and / or a brittle or aged bitumen

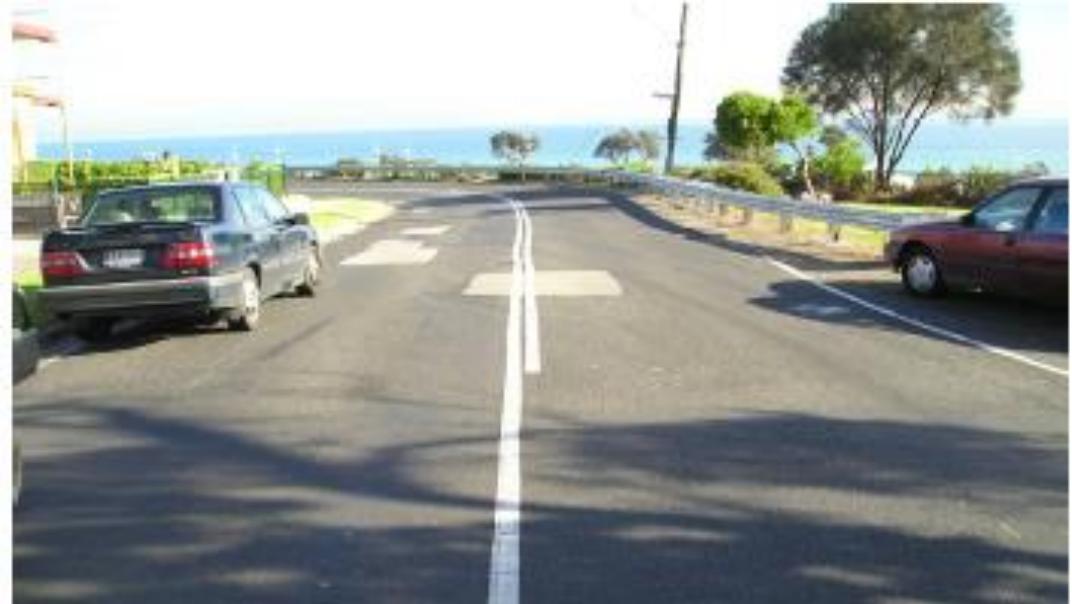
## Minor/ major patching treatments

Various patches are likely associated with routine maintenance of developing defects over the years and associated upgrading.

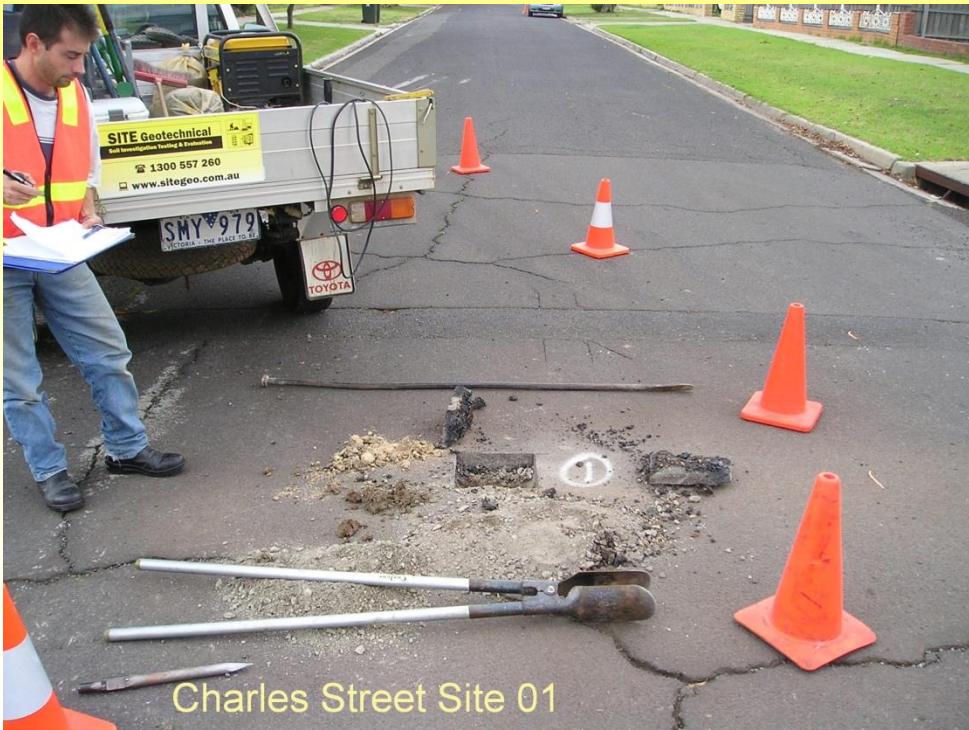
### Block Cracking

Block Cracks are commonly associated with cemented materials, likely caused by shrinkage or fatigue cracking of a underlying bound layer with reflective cracking eventually coming up through to the surfacing.

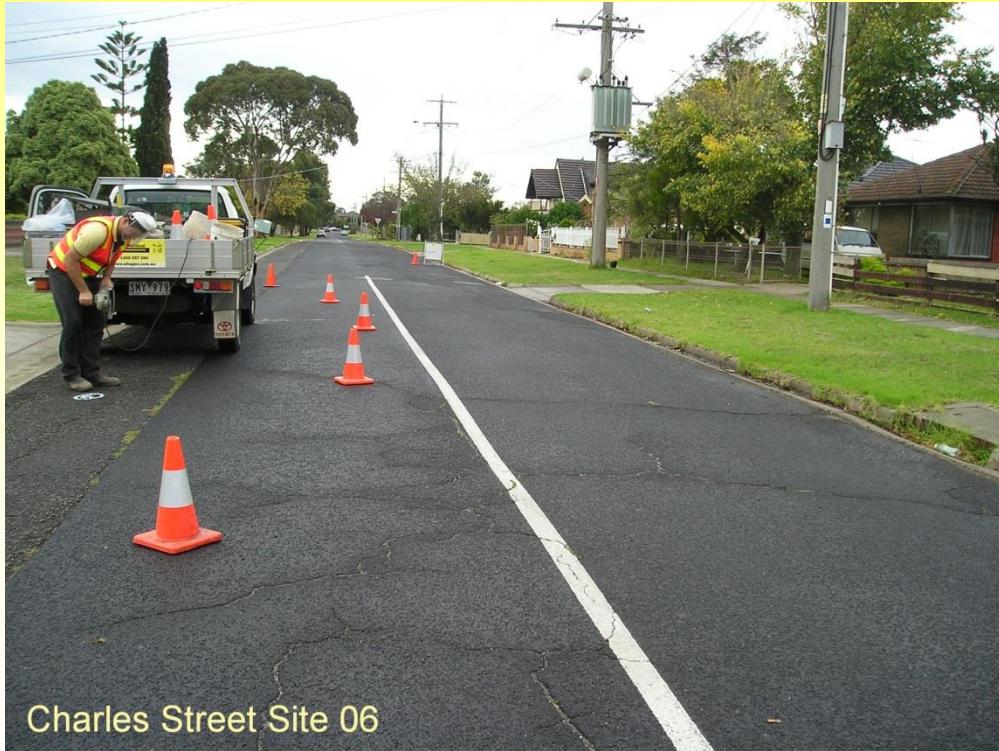
## Meandering cracking

Meandering cracking observed is likely associated differential moisture conditions or settlement within filled areas.

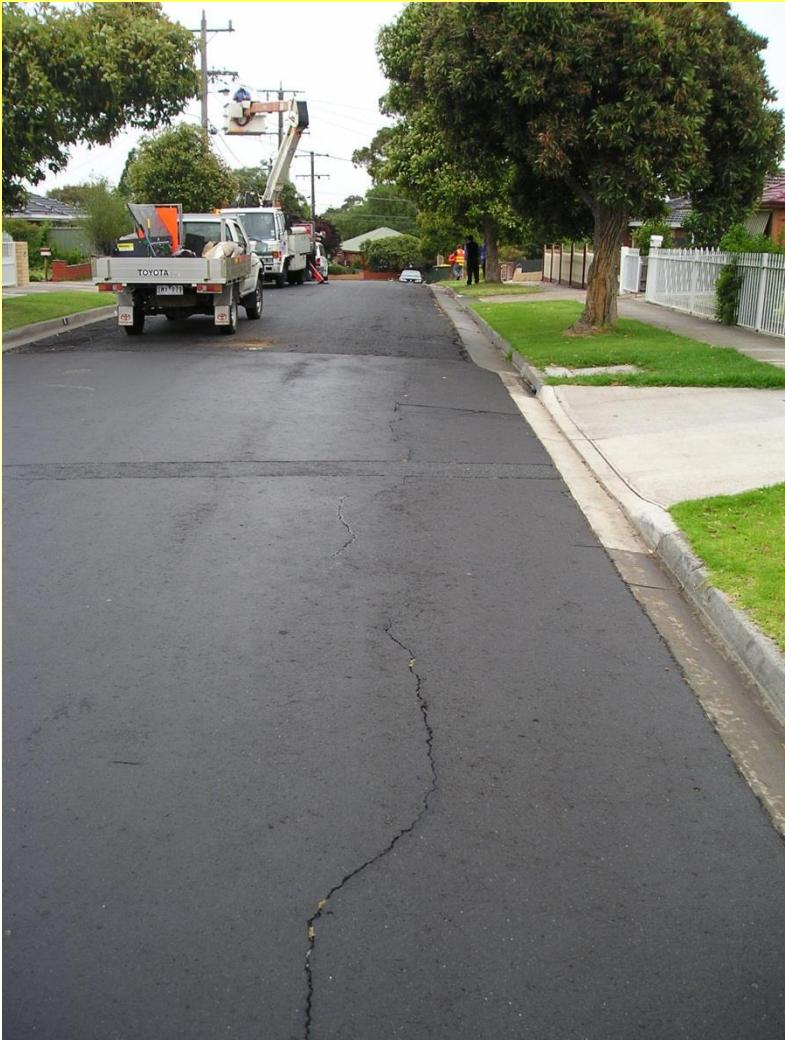
### Longitudinal and Transverse cracking

Longitudinal and Transverse cracking is likely associated with volume change of the underlying expansive subgrade, cyclical weakening and differential settlement or moisture conditions

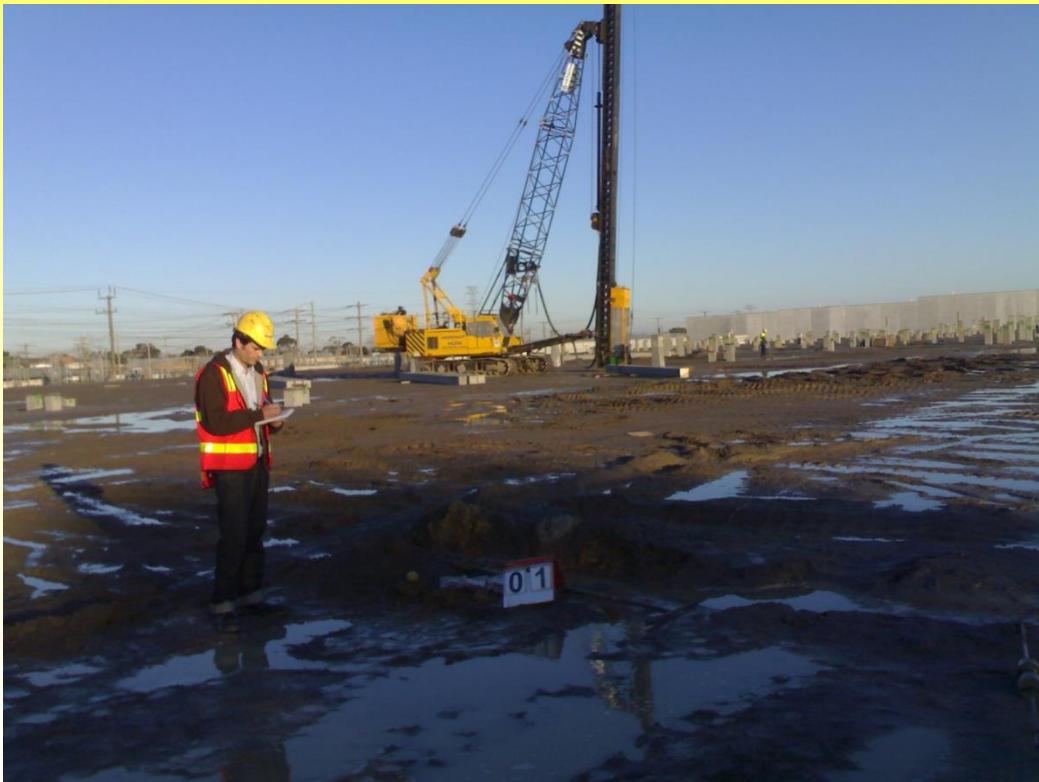
- Observations of a good working platform even after heavy rain which has allowed construction to proceed

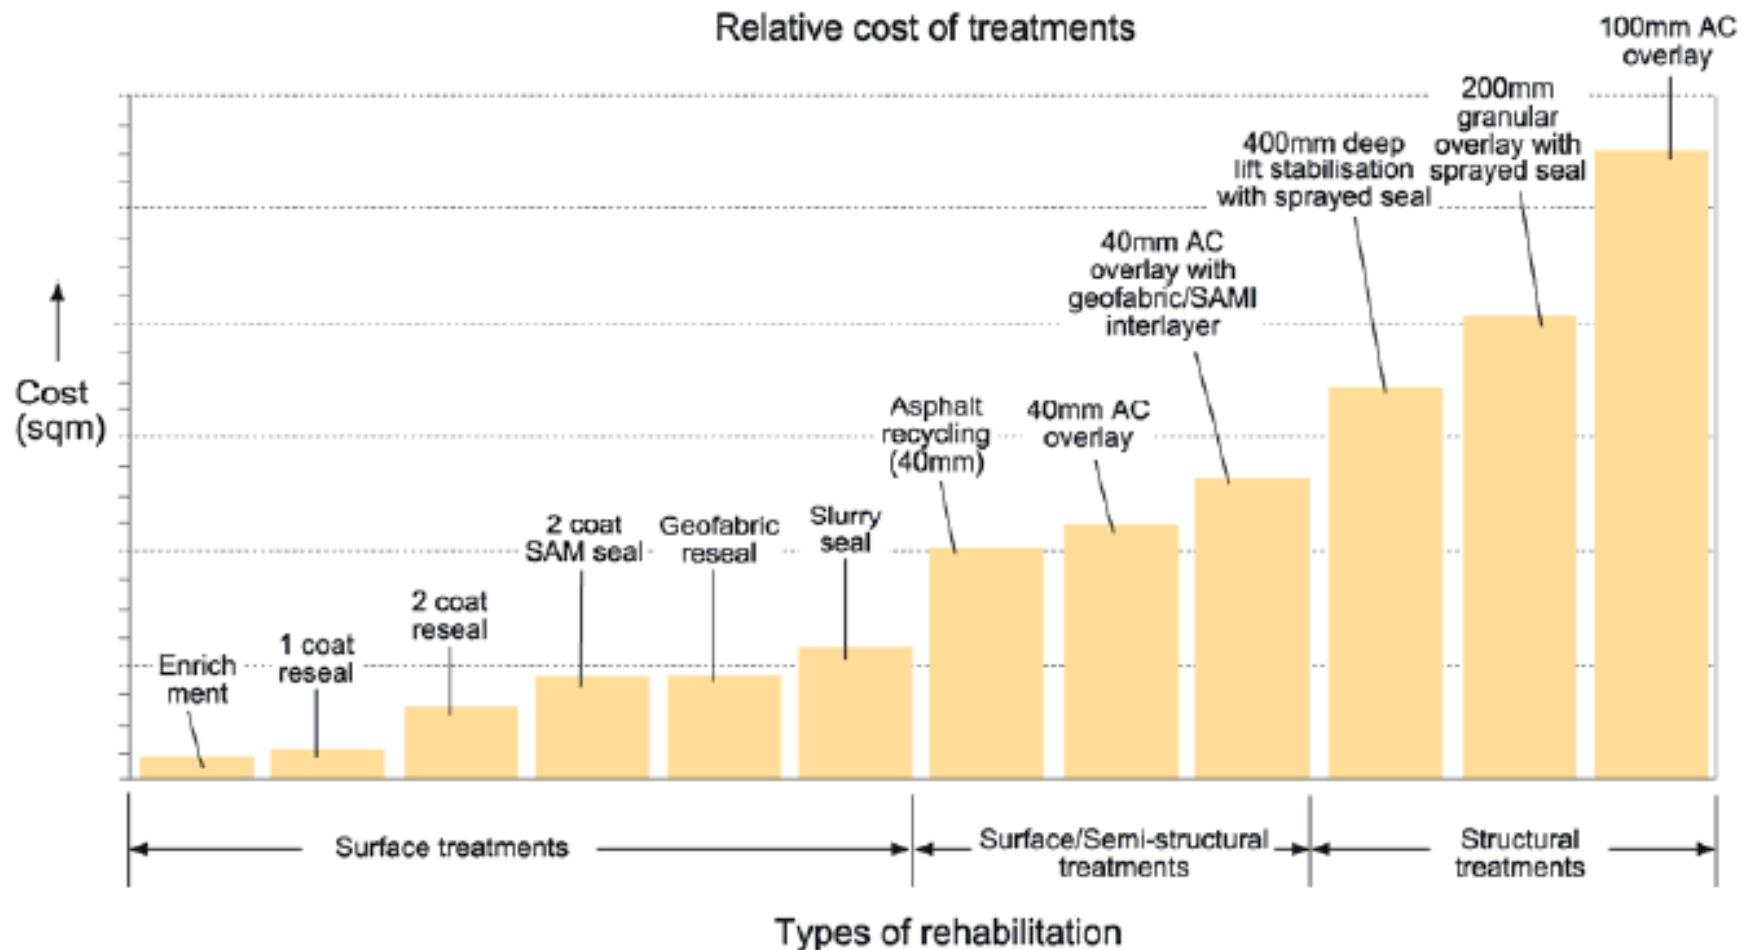
Figure F.1 : Relative Costs of Rehabilitation Treatments  
(Adapted from Ramanujam, 1998)

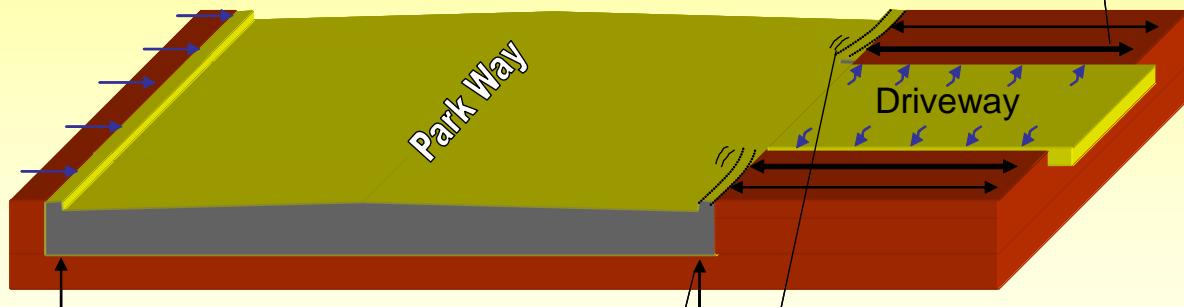
Differential horizontal loading exerted by reactive soils within road reserve. Concentrated Horizontal Forces from Road Reserve soils being wet up from adjacent driveway and road reserve runoff together with soils underlying driveways remaining under equilibrium conditions (i.e. potential cause of differential movement).

Little or no vertical displacements observed within distressed areas. Likely reason due to adequate cover with low reactive subgrade improvement materials

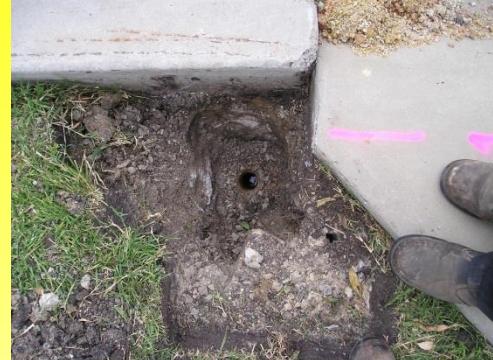
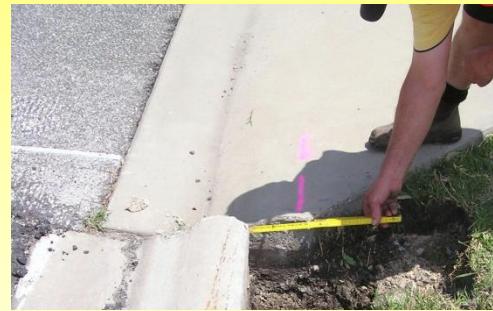
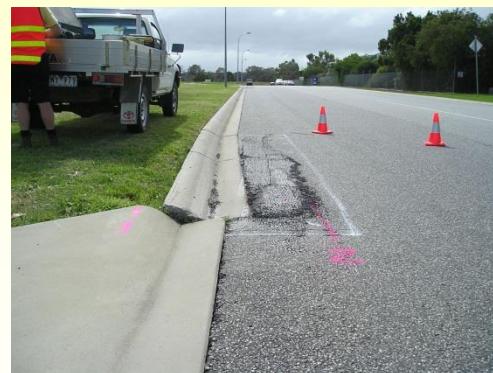
All failures observed are in the vicinity of driveways and include kerb and channel displacement and subsequent shoving of asphalt surfacing

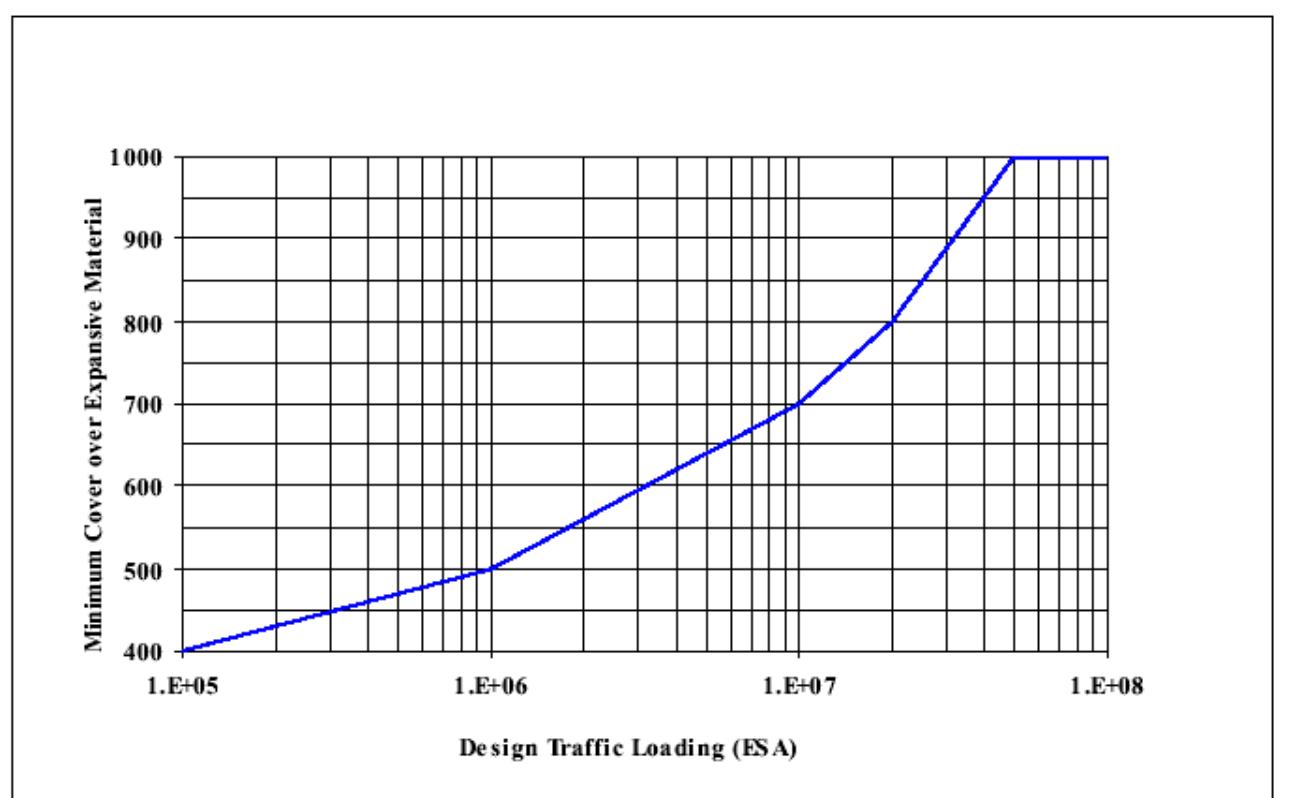
Figure 5.1 Minimum Cover Over Expansive Material

### Minimum Cover Over Expansive Material

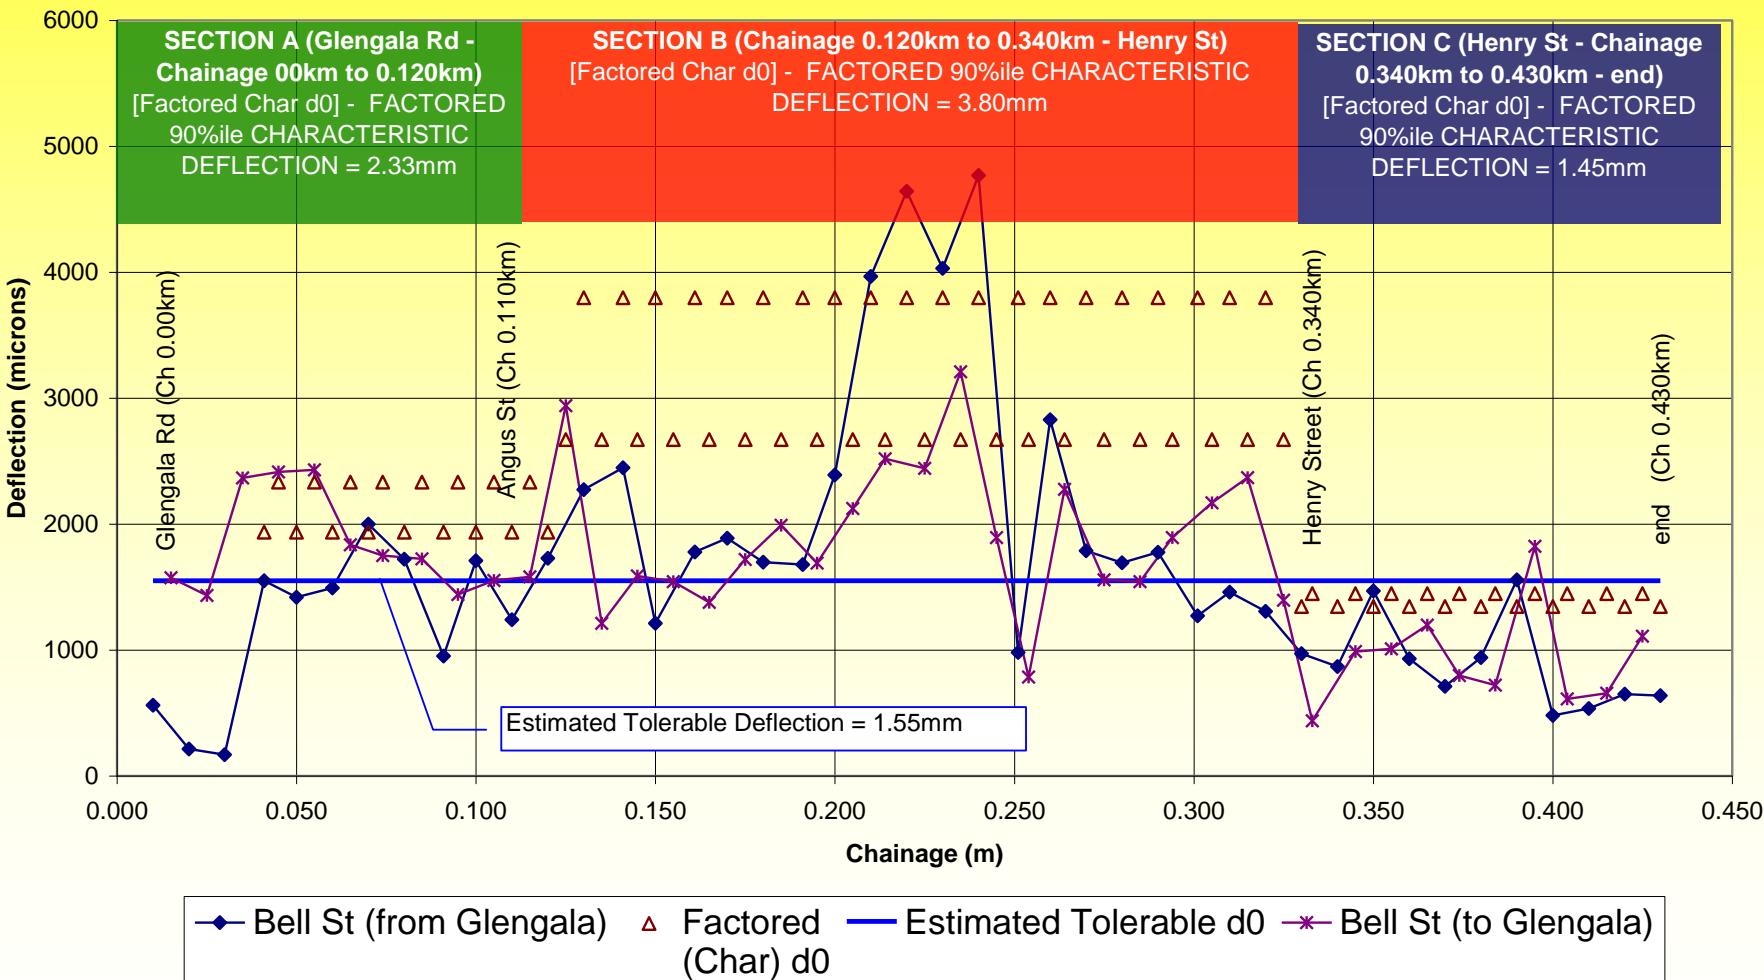
Chainage Versus Deflection for Bell Street (R0062-7)

FALLING WEIGHT DEFLECTOMETER (FWD) AND PaSE VEHICLE DEFLECTION TESTING AND ASSESSMENT OF DATA FOR PAVEMENT REHABILITATION OF EXISTING ROADS

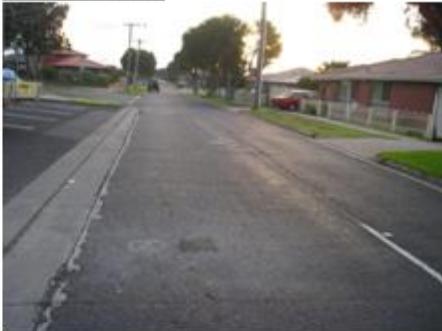
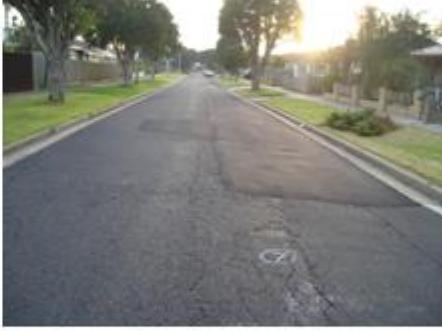
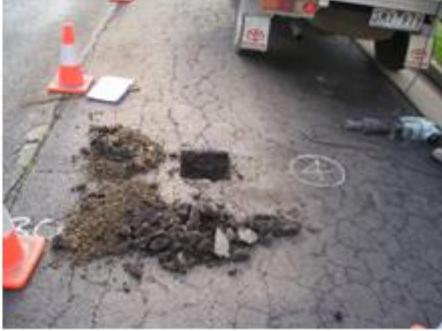
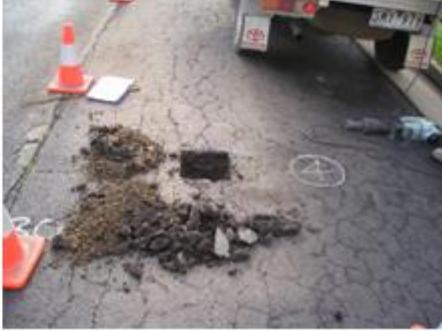
| <p><b>Defects</b></p> <p><u>Block Cracks</u> are likely associated with ageing and hardening of the surfacing, and were observed in the vicinity of the rigid pavement, and are likely associated with reflection from underlying joints.</p> <p>Various patches were observed throughout the investigated road length and are likely associated with routine maintenance of developing defects over the years and associated upgrading.</p> <p>Meandering cracking observed is likely associated differential moisture conditions or settlement within filled areas. Some sinking and rutting was also observed within areas inferred to have been filled.</p> <p>Crocodile cracking is likely associated with a fatigued pavement, inadequate pavement thickness or material and / or a brittle or aged bitumen</p> | <p><b>Defects</b> observed within the existing pavement have predominantly included various cracking and patching upgrading works as described below:</p> <p><b>Block Cracking</b></p> <p><b>Minor/major patching treatments</b></p> <p><b>Meandering cracking &amp; Sinking</b></p> <p><b>Crocodile Cracking</b></p> |

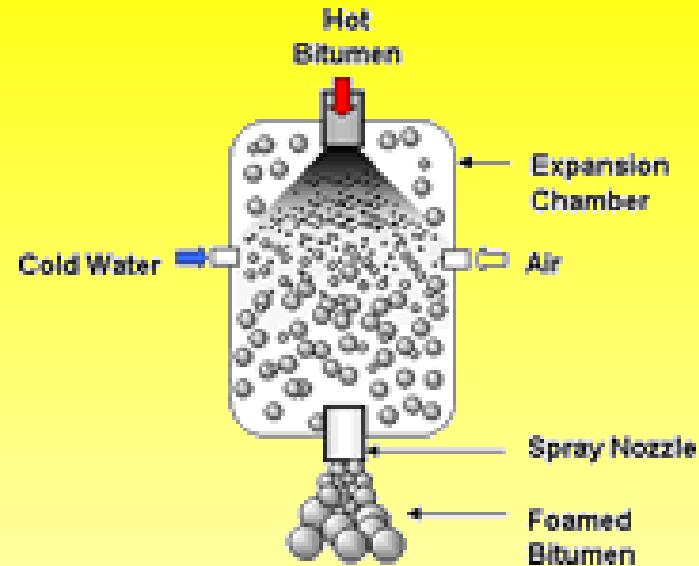
Improvement in granular material achieved by adding small amounts of bituminous binder (Usually 3% to 4% bitumen) a A foaming agent, and / or lime or cement and/or granular material. This process is undertaken to remedy deficiencies in the granular material with foam bitumen stabilised material being considered as (highly improved) granular material with enhanced strength characteristics. Further laboratory testing including modulus testing should be carried out to determine the most appropriate amount and type of binder to be used. Typically indirect tensile resilient modulus strengths in the order of 1,500MPa to 2,000MPa are required.

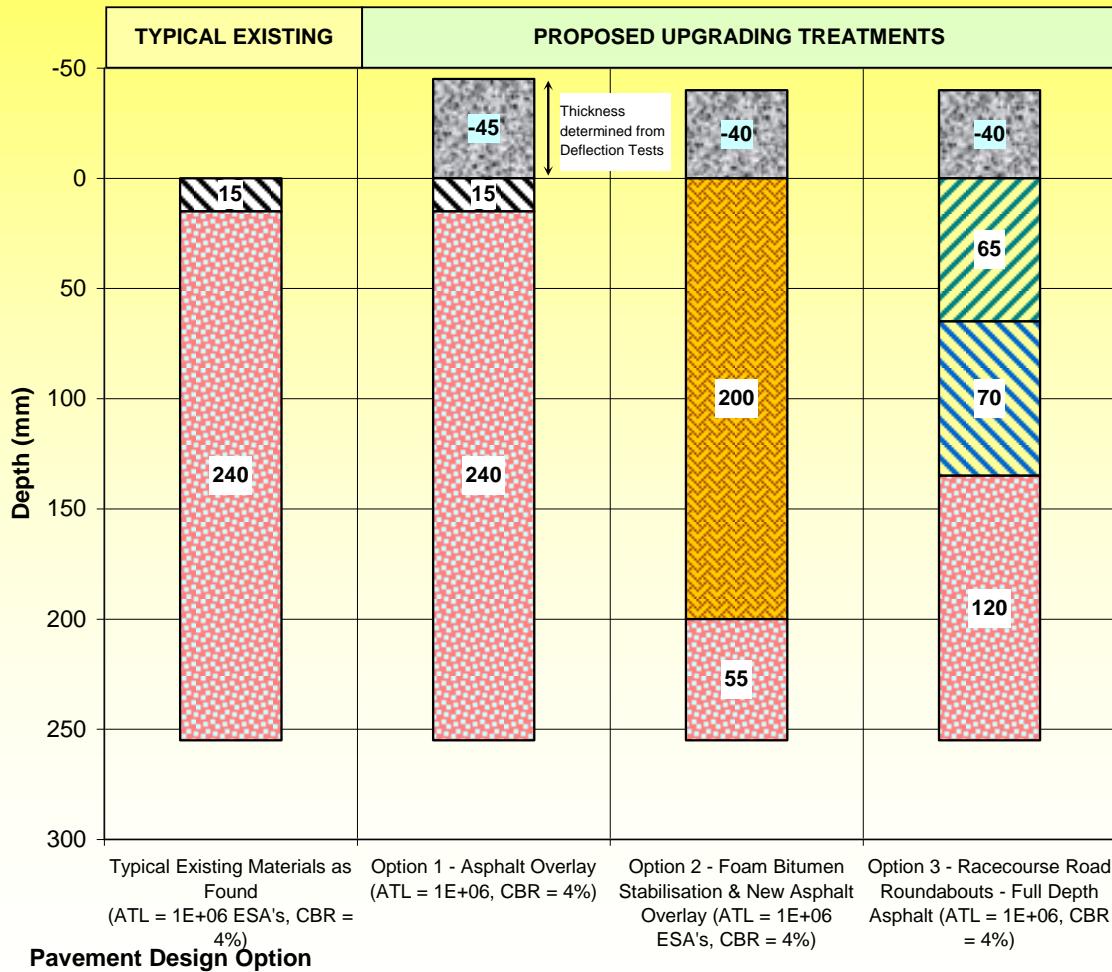
## Summary of Pavement Design Recommendations Racecourse Road MORNINGTON Report No.R0176

- ☒ Existing Granular Pavement Material as Found
- ☒ Lower Subbase - Class 4 CR (size 40mm)
- ☒ Subbase - Class 3 Cement Treated Crushed Rock (size 20mm)
- ☒ Existing Asphalt / Bituminous Stone Seal, Surfacing as found (to be prepared for asphalt overlay)
- ☒ Structural Coarse - Foam Bitumen Stabilisation
- ☒ Structural Coarse - Intermediate Asphalt Type SI (size 20mm)
- ☒ Structural Coarse - Intermediate Asphalt Type SI (size 20mm)
- Wearing Course - Heavy Duty Asphalt Type HG (size 14mm)
- Wearing Course - Heavy Duty Asphalt Type HG (size 14mm)

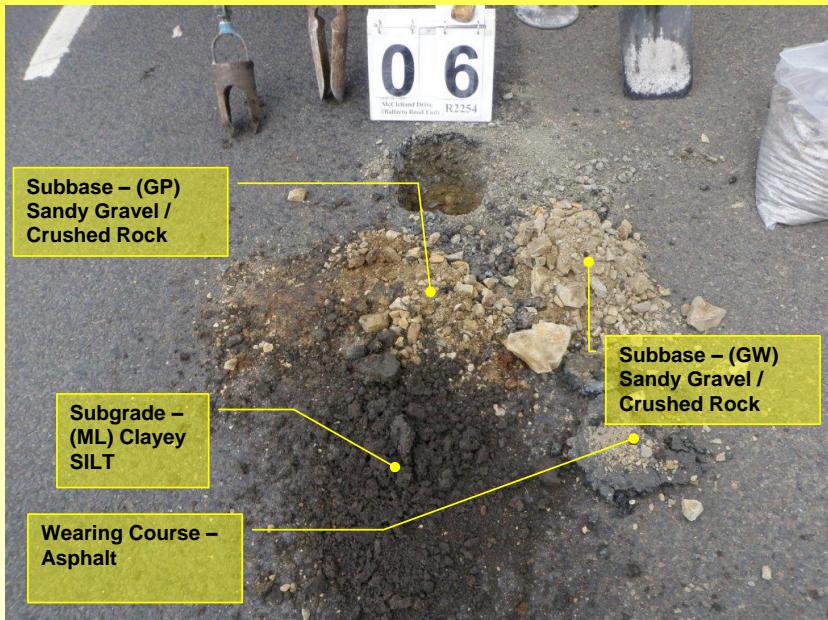
Typical Pictorial view of underlying pavement and subgrade materials encountered

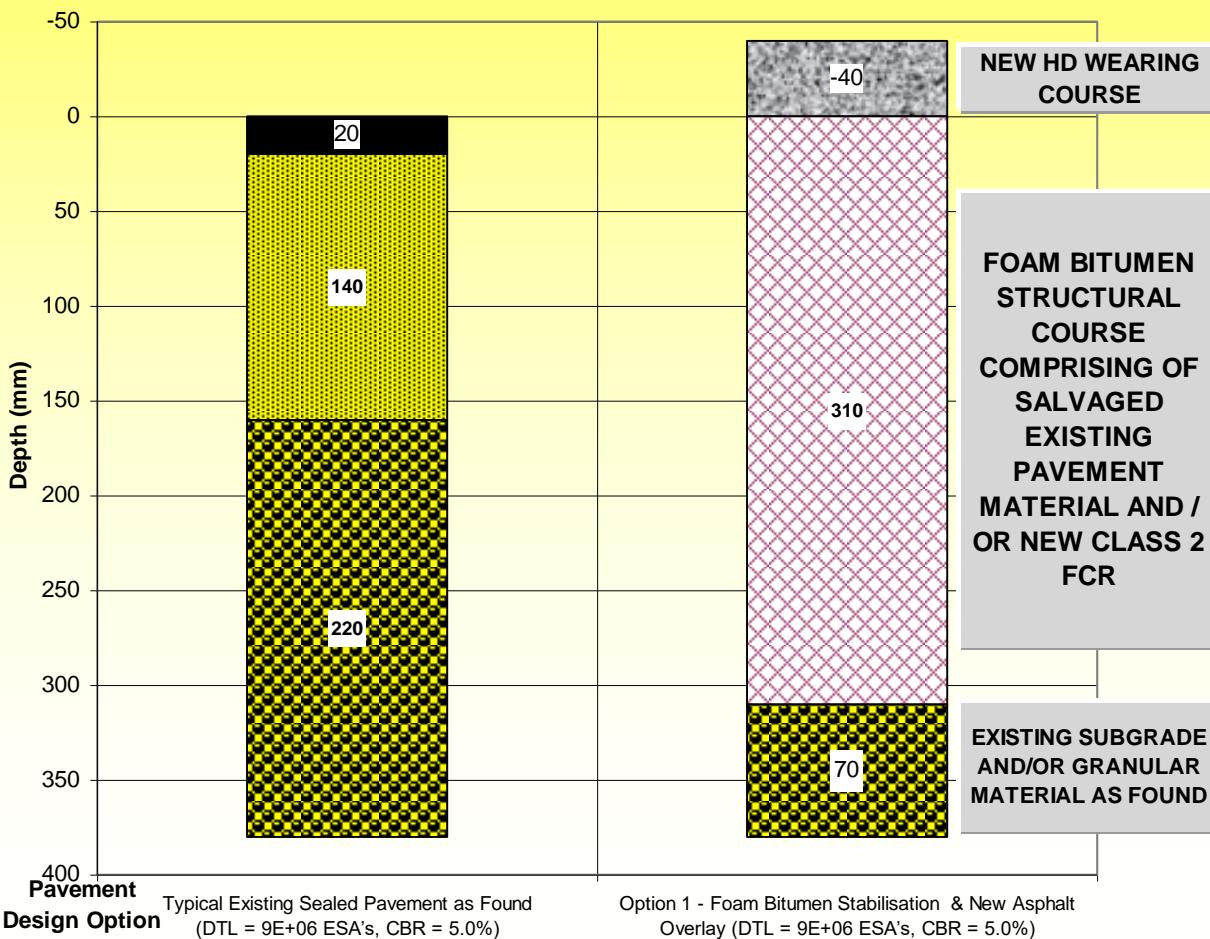
## Summary of Pavement Design Recommendations Mc Clelland Drive SKYE Report No.R2254

- ▣ Existing Poor Quality Subbase – (GP) Sandy medium GRAVEL Crushed Rock as Found
- ▣ Existing Good Quality Base – (GW) Sandy medium GRAVEL Crushed Rock as Found
- Existing Asphalt Seal Surfacing as found
- ☒ Structural Course - Foam Bitumen Stabilisation of Sandy Medium Gravel (Crushed Rock)
- ▣ Wearing Course - Heavy Duty Asphalt Type H (size 14mm)

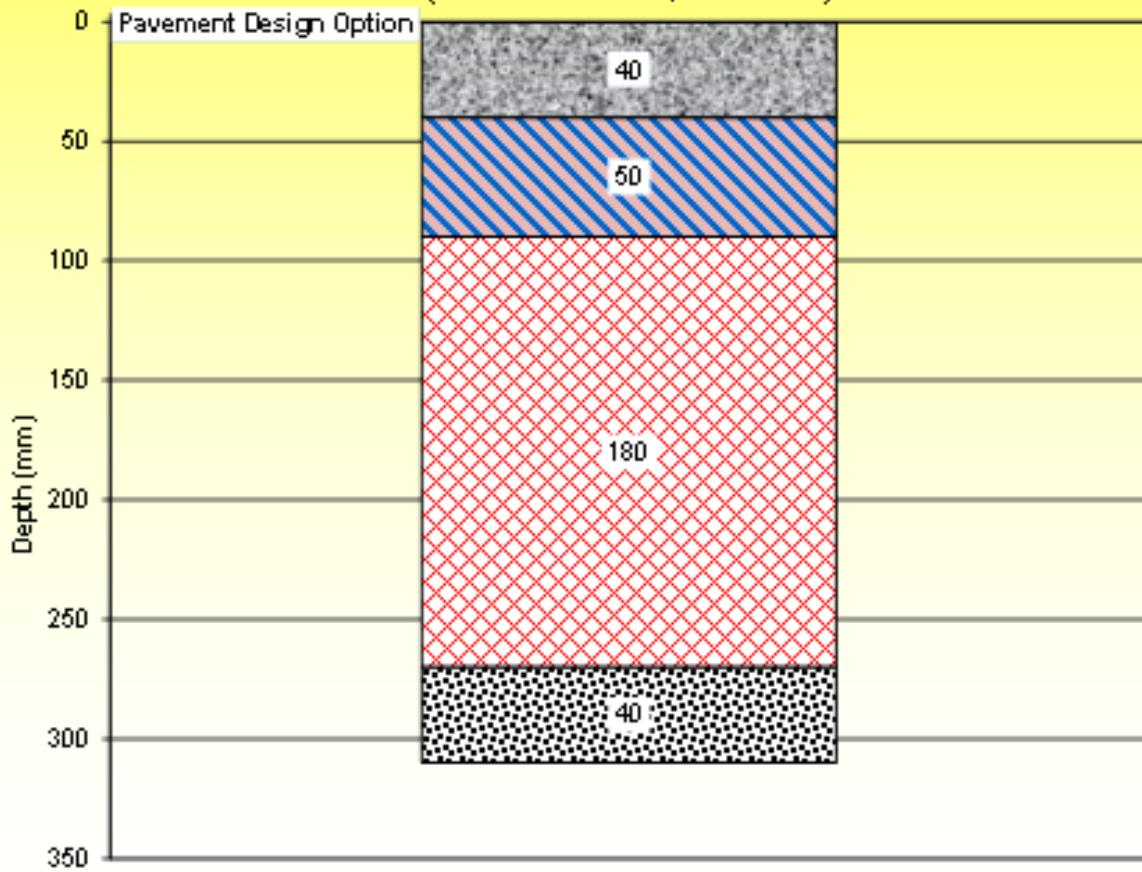
## Summary of Pavement Design Recommendations Brysons Road WARRANWOOD Report No.R3306

Option 1 – Foam Bitumen Stabilisation & New Granular & Asphalt Overlay  
(DTL = 2E+06 ESAs, CBR  $\geq$  50 %)

- Class 4 FCR or Suitable Salvaged Existing Pavement Material as Found CBR  $\geq$  15.0%
- Structural Course - Foam Bitumen Stabilisation of Existing Granular Materials as Found including Recycled Asphalt and Crushed Rock (E = 1,500 MPa)
- Structural Course - Intermediate Asphalt Type SI (size 20mm)
- Wearing Course - Heavy Duty Asphalt Type H or V5 (size 14mm)

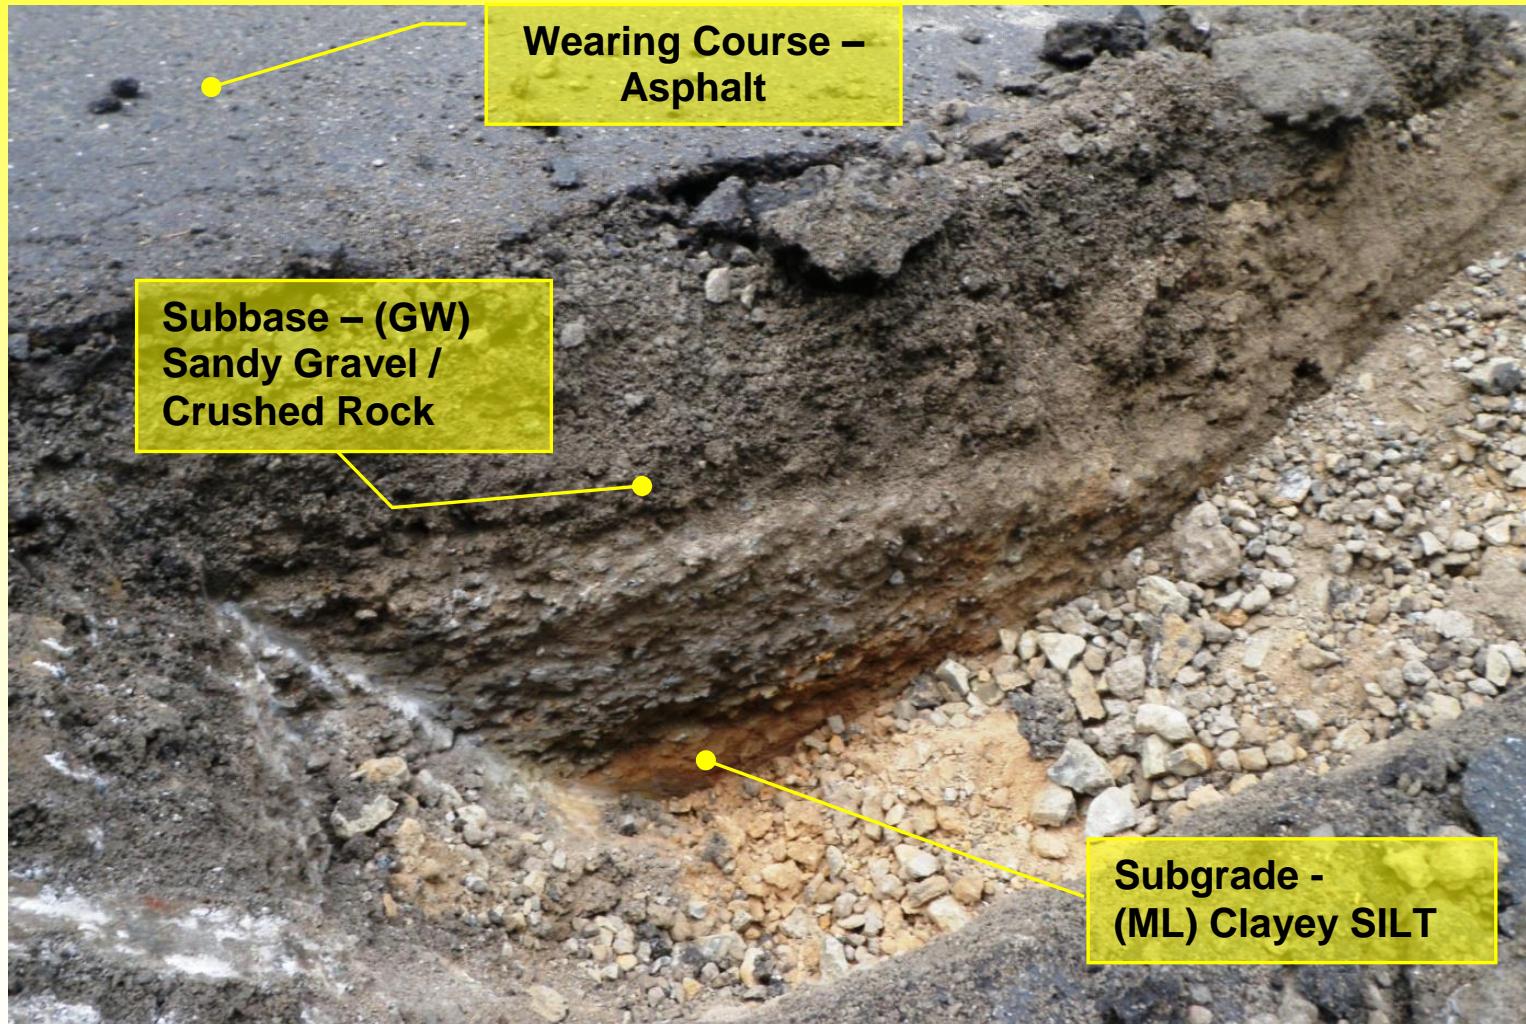
Typical Pictorial view of underlying pavement and subgrade materials encountered

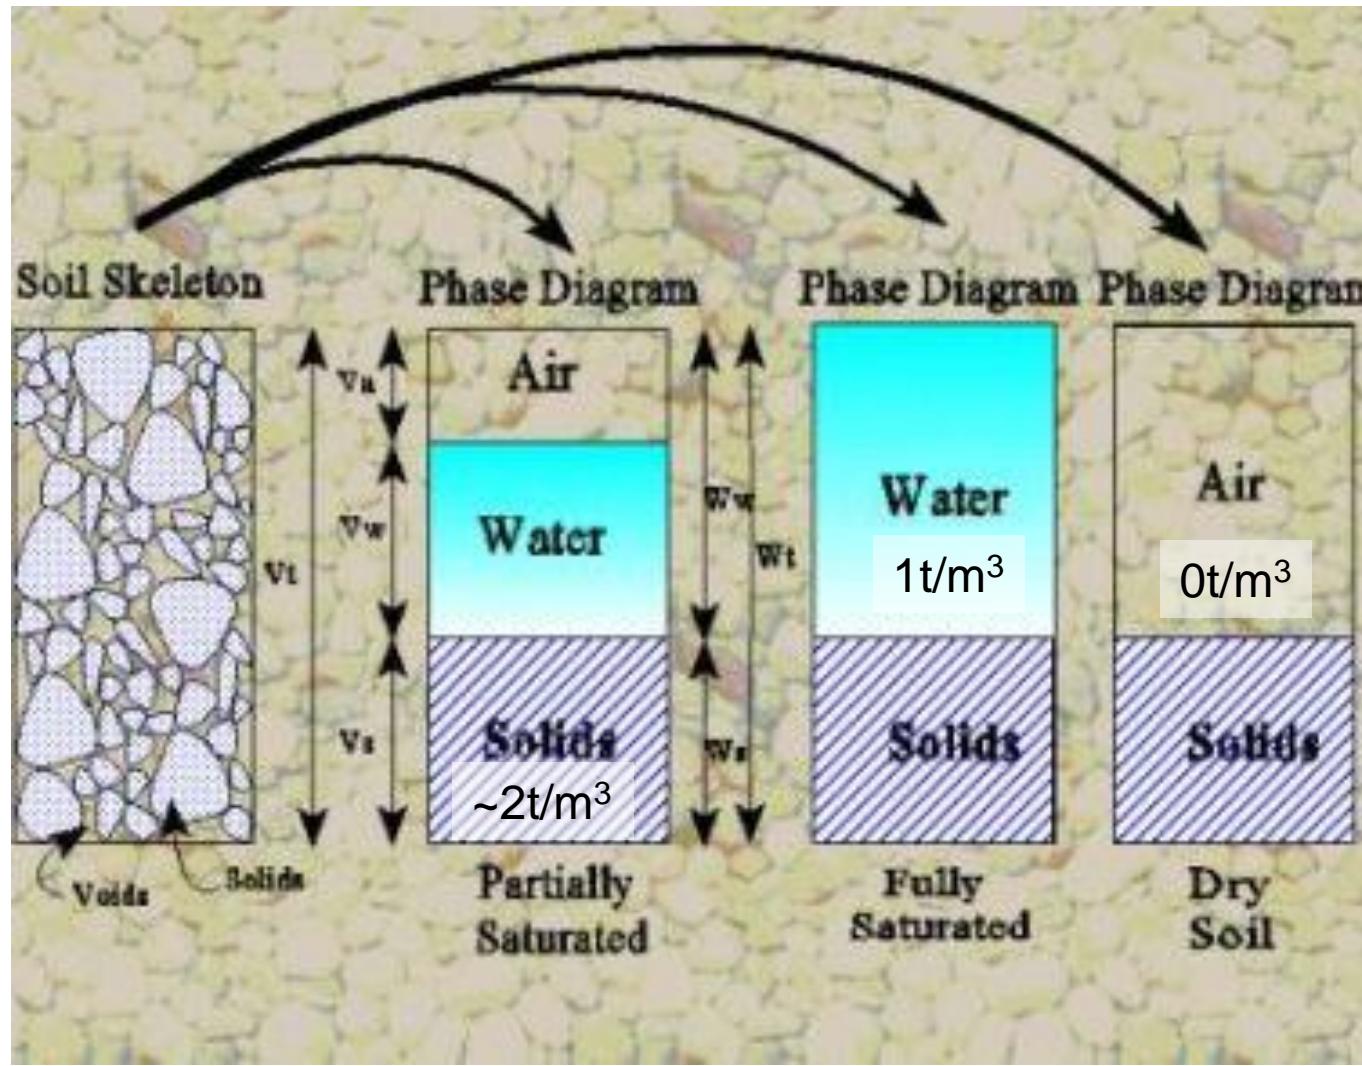
# DENSITY TESTING & PROCEDURES

After soil / gravel has been compacted field density/moisture results are taken (Field Results)

These results are later compared with figures determined within the laboratory

Comparison between the Field and Laboratory results are used to give a ratio or percentage
